Prepared by Toole Design Group  
April 4, 2014

## What We Set Out to Observe: Westlake Design, Circulation Patterns and Counts

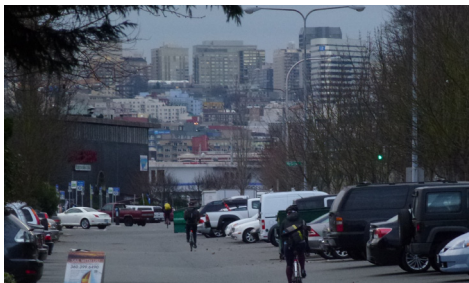
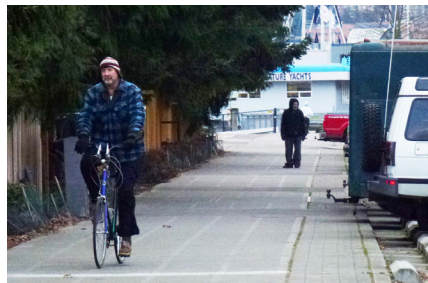
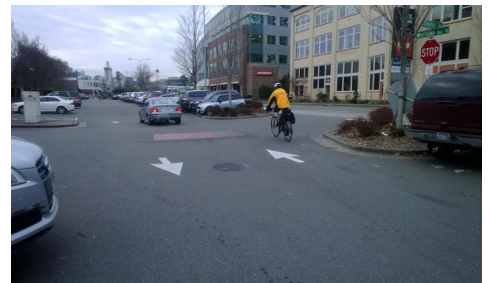
*Bicyclists using the parking lot, sidewalk and negotiating a driveway*

- Overall, pedestrian volumes are typically higher than bicycle volumes - many pedestrians live in and use this corridor for business, to access transit, and for recreation.
- People on bicycles tend to travel northbound using either the sidewalk or service drive and travel southbound using the parking lot.

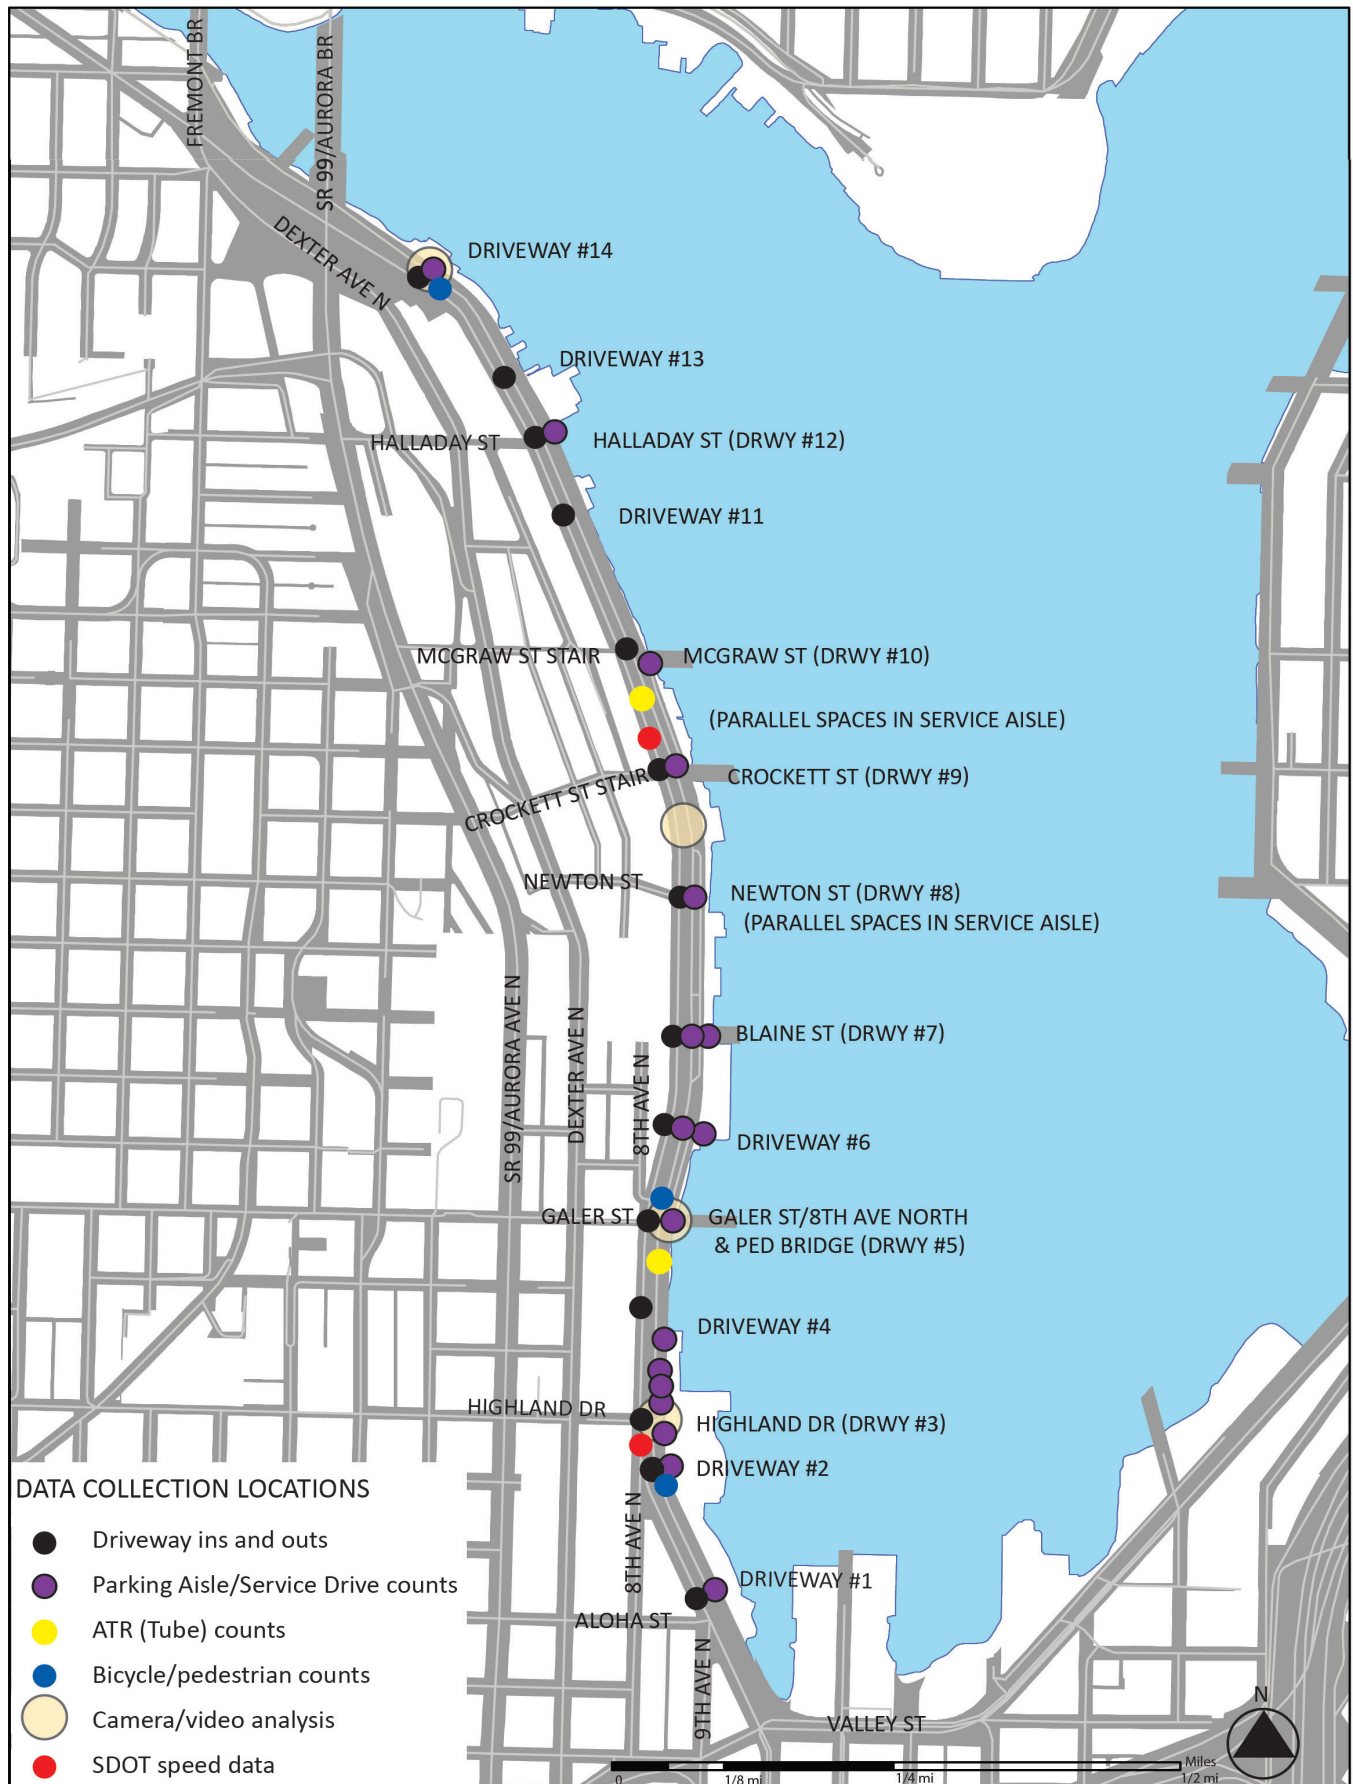
FIGURE 1: DATA COLLECTION LOCATIONS AND TYPES

Traffic data was collected in September 2013. A range of days and times were selected to capture both peak and off-peak hours (See Table 1). Figure 1 shows the locations of the data collection by type. Driveways were numbered sequentially from south to north for reference.

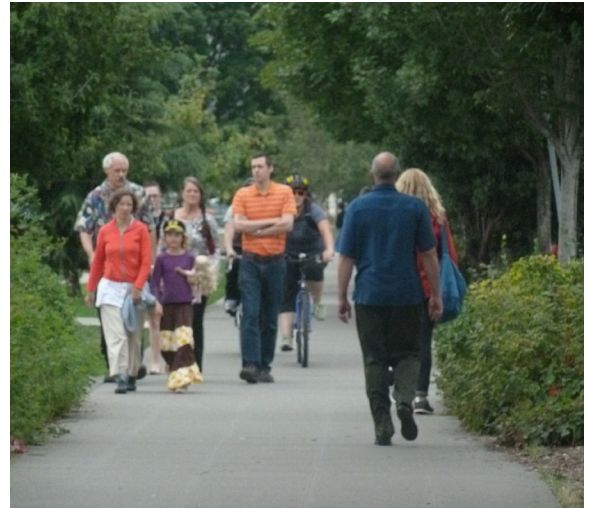
***High pedestrian volumes near the AGC Building***

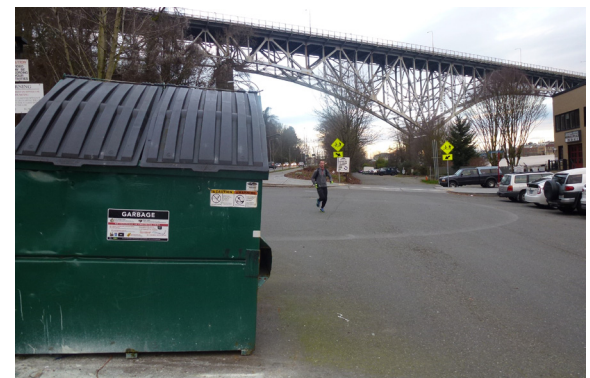
- It is difficult for motorists backing out of parking spaces to see bicyclists, especially children and people on bicycles moving quickly.
- The planting along Westlake Avenue North and landscaping adjacent to driveways limit sight distance for motorists turning into/out of the parking area.
- Parked cars and dumpsters also limit sight distance for all parking lot users.

***Pedestrian and dumpster near Driveway #14***

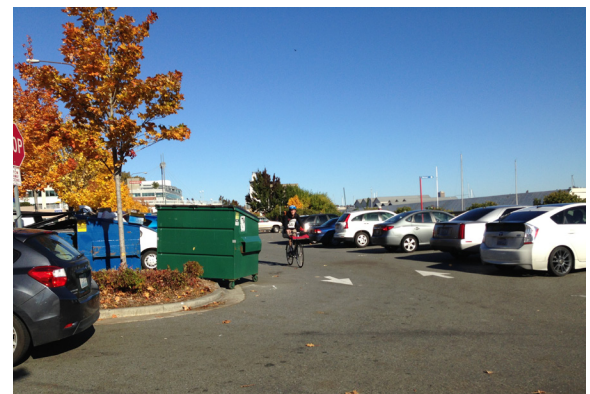
***Bicyclist and dumpster near Driveway #2***

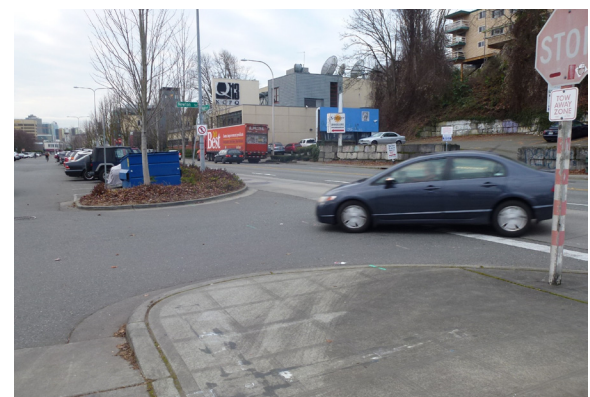
- People driving cars tend to turn quickly from Westlake Avenue North into the parking area, likely due to the speed and volume of traffic on Westlake, combined with sight distance limitations, and lack of turning pockets.

***Motor vehicle turning in parking area at Newton Street***

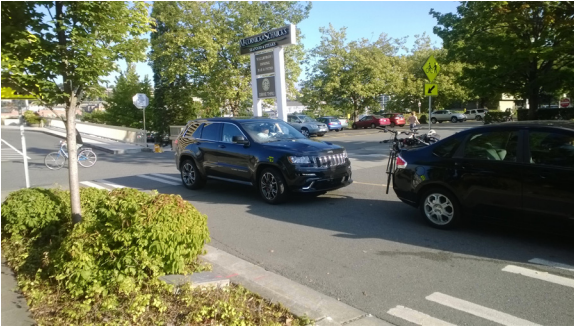
**Queuing motor vehicles at the Highland Drive traffic signal**

- Motor vehicles waiting for a green light to exit onto Westlake Avenue North from the parking lot can block north-south movement by motor vehicles and bicycles using the parking drive aisles. This issue was observed at the signalized driveways more frequently than at the stop-controlled driveways.

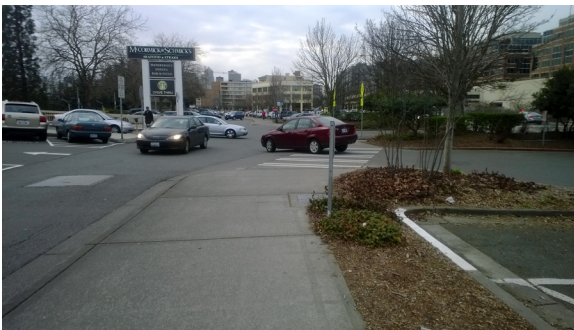
**Motor vehicle activity at the AGC Building entrance/ Highland Drive traffic signal**

- This is a complex, 7-legged intersection with the highest volume of turning traffic. It is heavily used by all modes and motor vehicles queue to enter/leave the garage, the Starbucks drive-through and the parking area on Westlake Avenue North. Conflicts were observed between crossing bicyclists and motorists entering and exiting Highland Drive onto Westlake Avenue North.

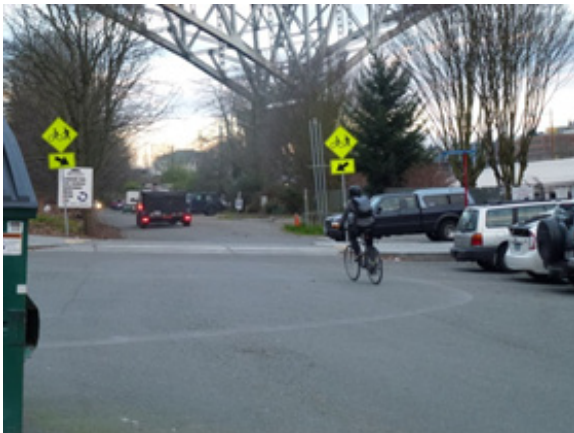
**Northbound bicyclist at Driveway #14**

- At Driveway #14, where the parking drive terminates into a driveway and the Cheshiahud Lake Union Loop connects to the west sidewalk on Westlake Avenue North, conflicts were observed between people on bicycles negotiating two close 90 degree turns from the sidewalk to the parking lot, and motorists entering/exiting the parking lot or the driveway to the north.

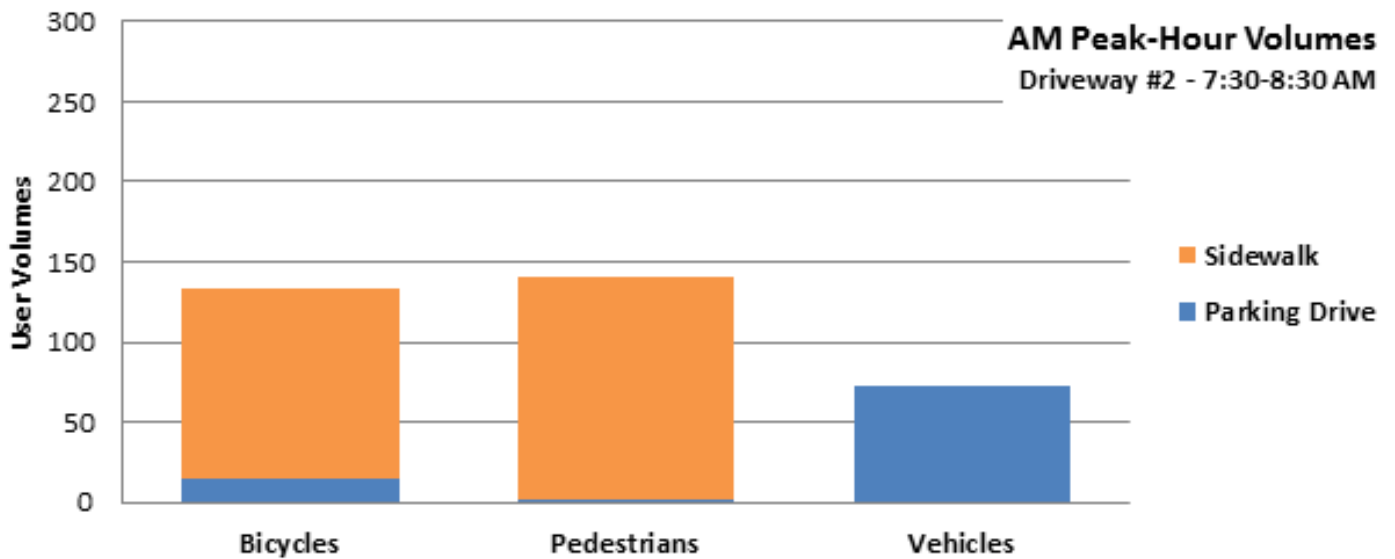
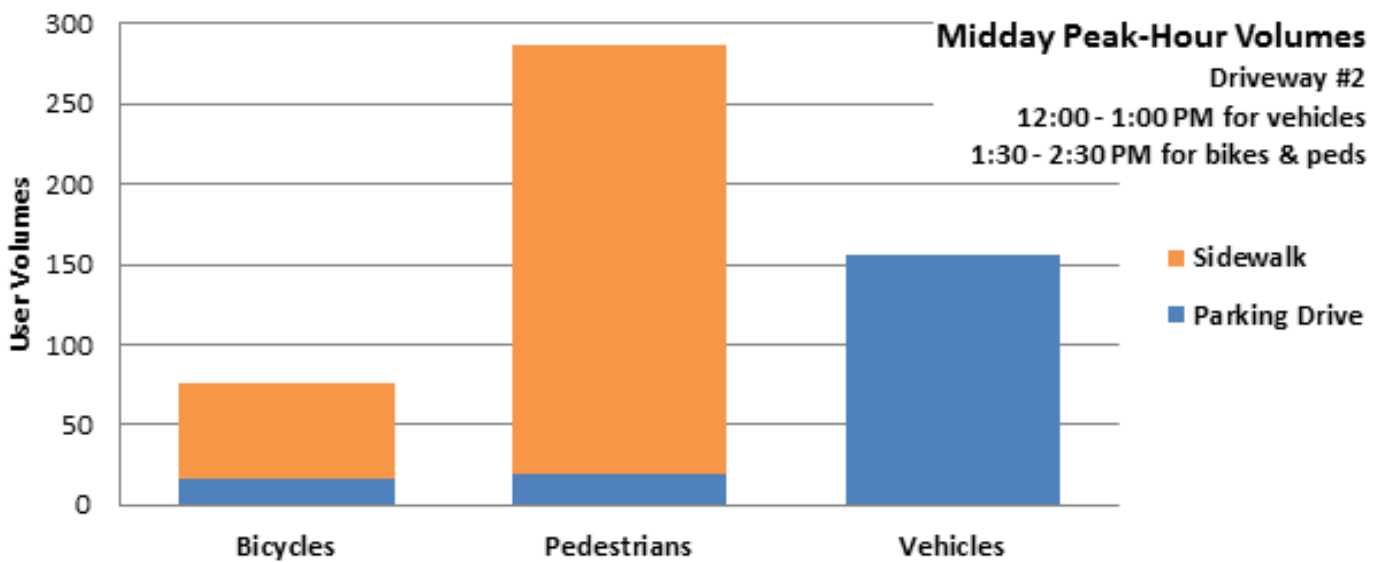
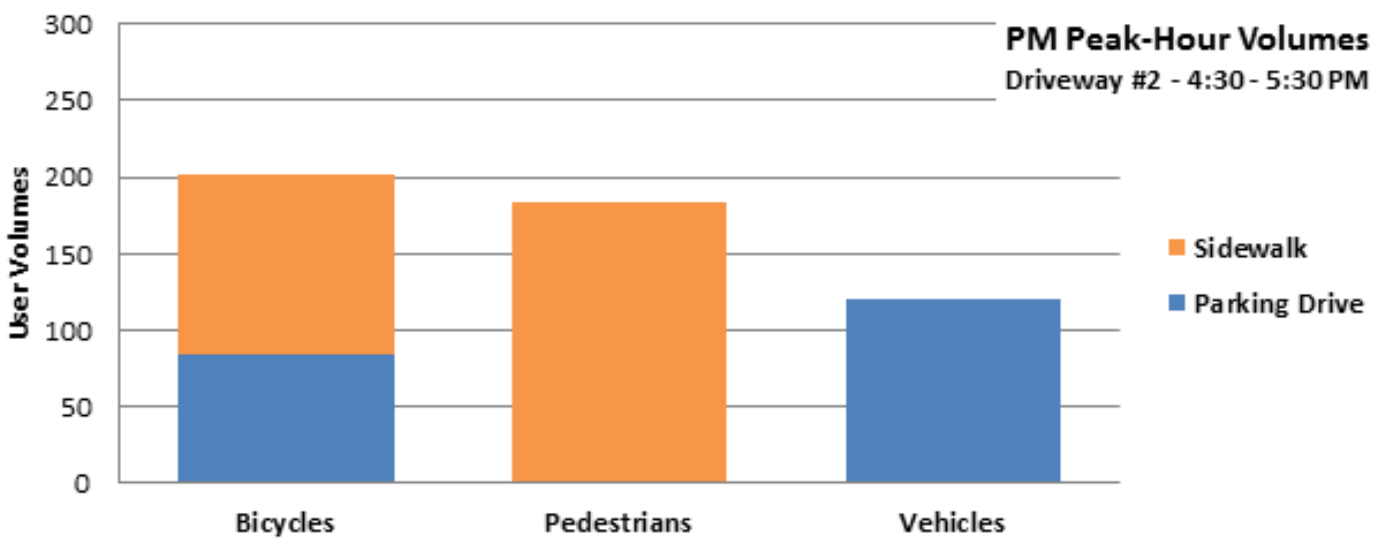
FIGURE 2: PEAK HOUR MULTI-MODAL VOLUMES NEAR DRIVEWAY #2 AND THE PARKING DRIVE

- Over 600 pedestrians were counted near Driveway #2 during the three peak times
- Pedestrian volumes are highest during the midday
- Over 400 bicyclists were counted near Driveway #2 during the three peak times
- Figure 2 shows multi-modal volumes for the AM, midday and PM

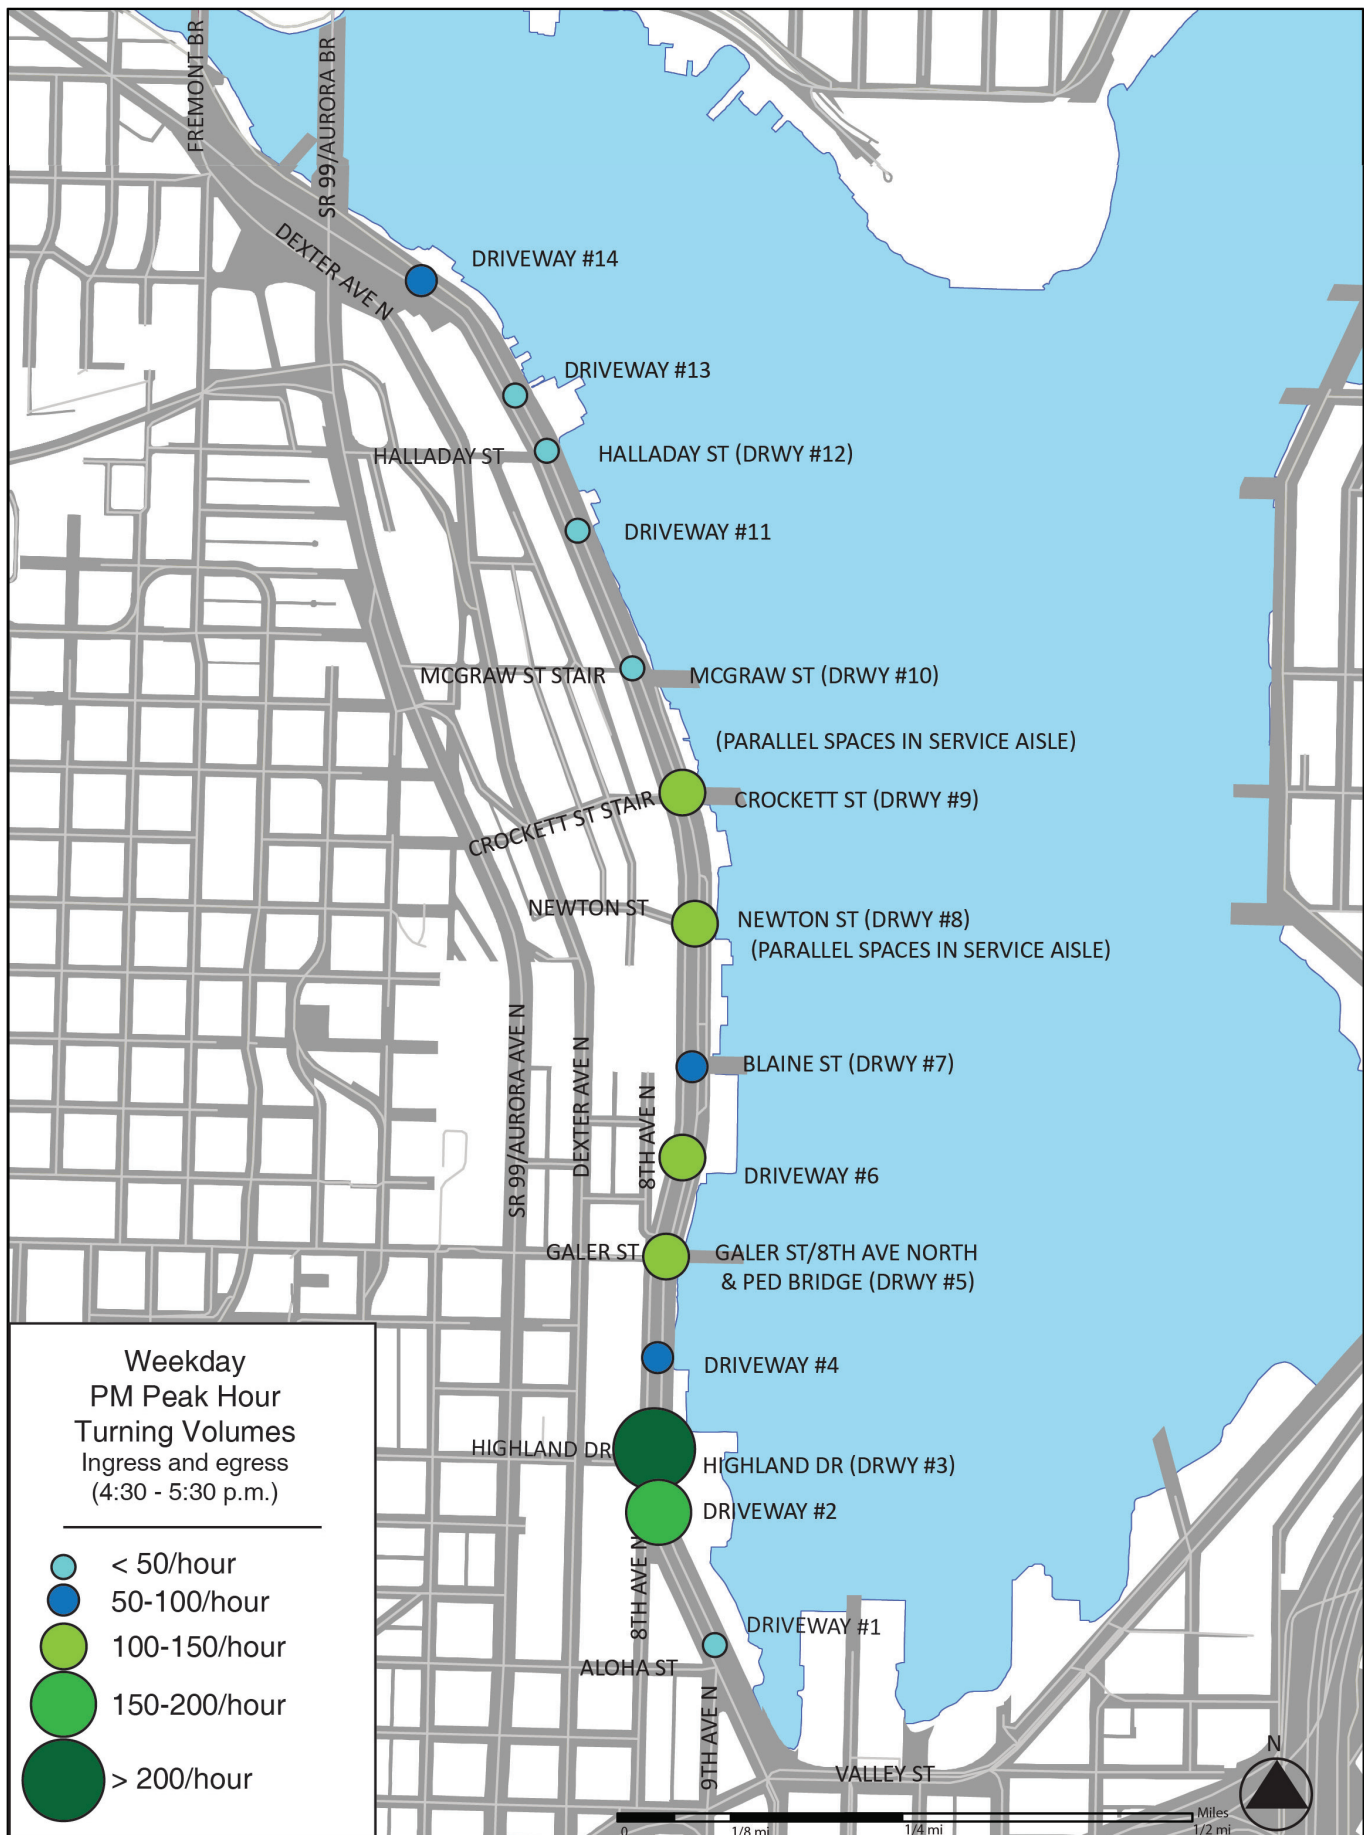
FIGURE 3: PEAK HOUR TURNING VOLUMES INTO AND OUT OF THE PARKING LOT FROM WESTLAKE AVENUE NORTH

- 4:30 to 5:30 PM is the busiest time for most driveways
- Southern driveways (from Crockett Street south to Driveway #2) have the highest use volumes
- Highland Drive/Driveway #3 has the highest turning volumes
- See Figure 3 for a sample of turning volumes categorized by driveway and street end
